**3M** 3M TOUCH SYSTEMS  
METHUEN, MA  
USA

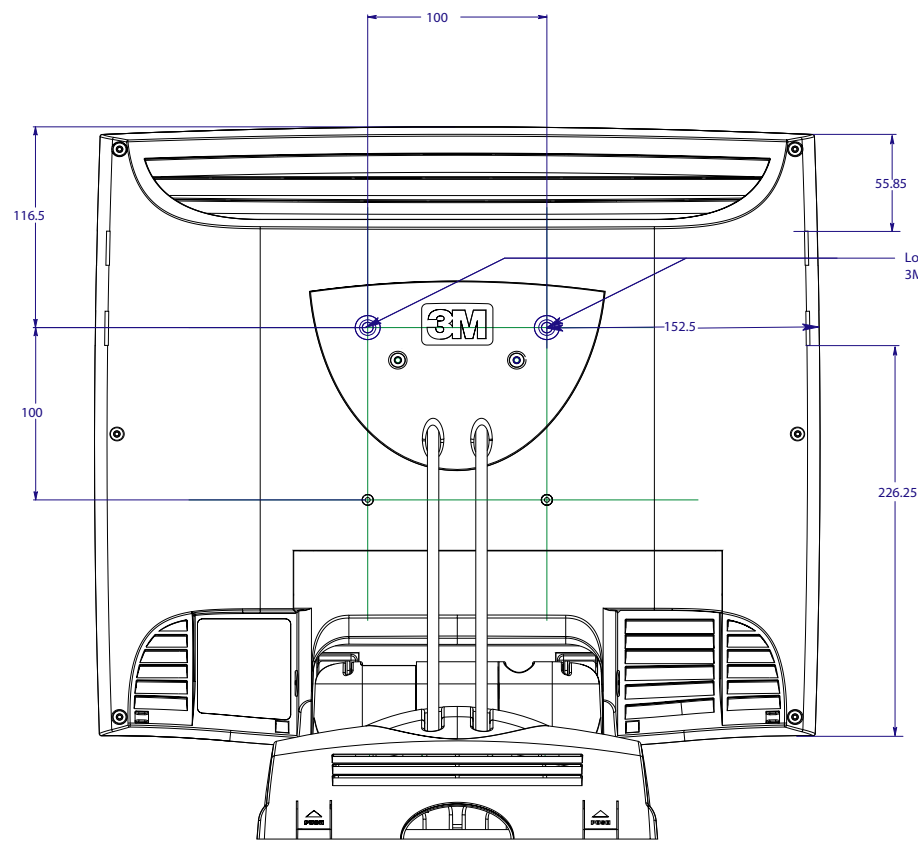
Location of upper VESA mount holes.  
3M cover to be removed for access.
